Joint Reinforcement as Primary Shear Reinforcement for Concrete Masonry Shear Walls

Greg Baenziger¹ and Max L. Porter²

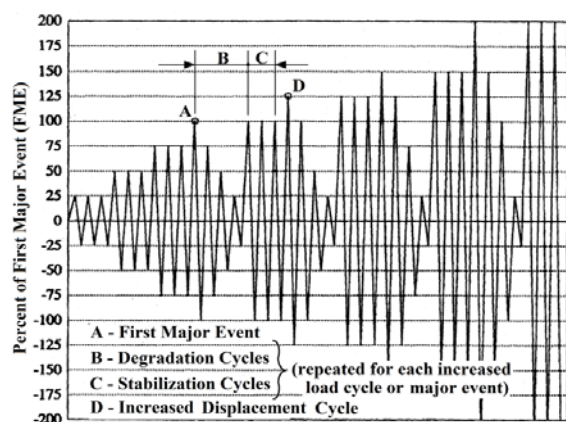
Figure 5 – TCCMAR Cyclic Loading Pattern

Instrumentation consisted of load cells, strain gages, and string potentiometers. Potentiometers were attached to the concrete base and to the braced instrument frame, which was supported by the concrete base. The instrument support frame is visible at the periphery of the test wall in Figure 1, and the hydraulic actuators and load cells are visible in the upper corners. The mechanism for load transfer is illustrated in Figure 4. Horizontal loads were applied slowly at the top of the cantilever shear walls using displacement control and following the procedure recommended by the U.S. Coordinated Program for Masonry Building Research and the Technical Coordinating Committee for Masonry Research (TCCMAR) (Porter 1987). The load sequence, illustrated in Figure 5, consisted of sets of three cycles at increasing displacements until a major event, such as significant cracking, occurred followed by sets of degradation cycles, three stabilization cycles, and an increased displacement cycle until the wall failed.

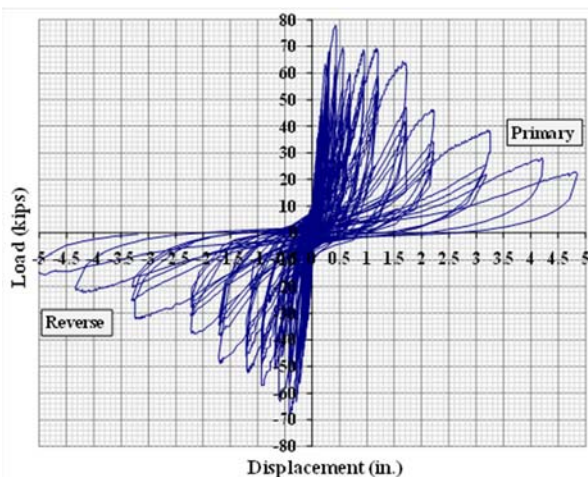
Figure 7 – Shear Wall 6 Load-Displacement

Shear Wall 6, with 3/16-inch (4.8-mm) double seismic style joint reinforcement in every bed joint, behaved more robustly than Shear Walls 1 and 2. Shear Wall 6 demonstrated a greater level of shear capacity and ductility. Shear Wall 6 had greater areas of well-distributed reinforcement to restrict the crack size and distribute deformations uniformly across the wall. The load-displacement diagram for Shear Wall 6 is provided in Figure 7.

The improved anchorage at the top of the wall and the second jamb cell increased initial stiffness and added to the greater strength of the wall after significant damage to the ungrouted panels. The moment resistance of the reinforced and grouted cells around the ungrouted panels helped to prolong the wall strength and increase drift capacity. Two stages of wall damage are shown in Figures 6(d) and 6(e), maximum shear capacity and maximum wall displacement, respectively. Shear Wall 6 was not directly comparable to the other walls of the group, but the test demonstrated the possible increase in capacity and displacement due to greater areas of horizontal joint reinforcement distributed at a small spacing with improved wall details to include top hooks.

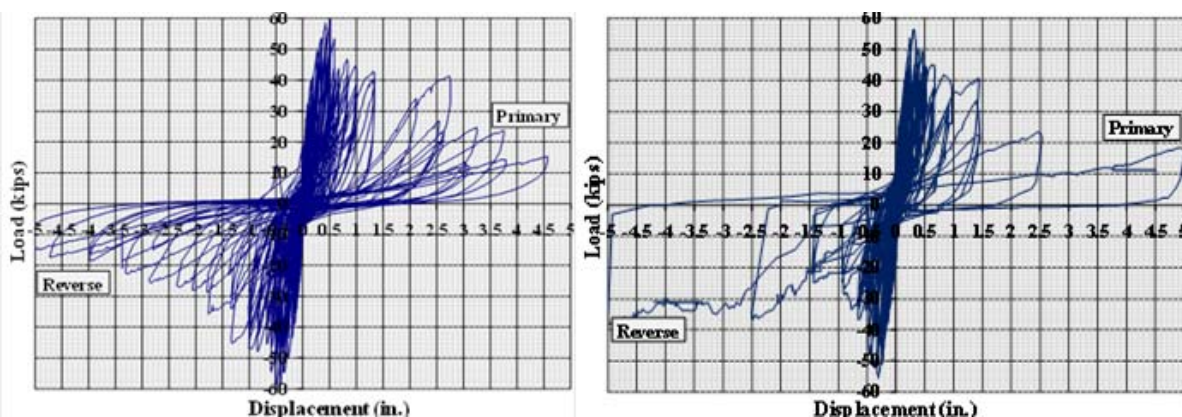
Figure 8 – Load-Displacement Plots: (a) Shear Wall 5 (left) and (b) Shear Wall 7 (right)

the stronger reinforced and grouted cells around the ungrouted panels. The joint reinforcement remained intact and provided a stabilizing effect for the lower strength masonry wall. The broader load-displacement loops in Figure 8(a) indicate a more robust energy dissipation capacity and ductility associated with shear walls that have reserve capacity after significant displacement. Cracking in Shear Wall 5 is illustrated in Figure 6(f).

Shear Wall 7, with 2 #4 (M#13) bars in a mid-height bond beam, was similar to other bond beam walls, with a significant diagonal crack that opened after 0.6 inches (15.2 mm) displacement in the reverse direction. Sliding and delamination occurred after displacements exceeded one inch (25 mm), in Figure 9(a). The mid-height bars restrained cracking, but the bond beam acted as a strut contributing to delamination at each end. The greater prism strength of Shear Wall 7 over Shear Wall 5 is not reflected in the overall wall peak shear capacity (93.6% of that of Shear Wall 5). Increased loads, resulted in sliding and interaction with the test frame, visible in the bottom left of the load-displacement graph beyond -1.5 inches (38.1 mm) displacement, Figure 8(b).

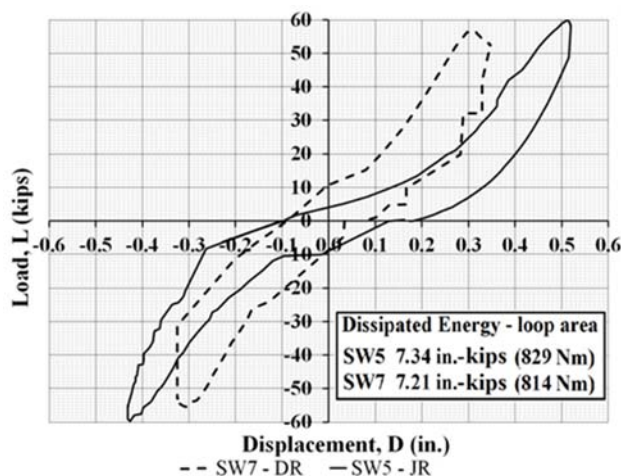
Figure 13 – Peak Load Loops for SW5 and SW7. The loop areas are almost equal indicating that energy dissipation in the walls is nearly equivalent.

The shear capacity of walls with joint reinforcement was approximately equal to or greater than that of walls with deformed reinforcement. Based on averaged wall strengths of comparable walls, walls with joint reinforcement are 9% stronger than the corresponding walls with deformed reinforcement. The walls with joint reinforcement had a greater number of smaller cracks and more uniform distribution and size of cracks than the walls with deformed reinforcement. The walls with joint reinforcement acted as a whole, whereas, the upper half of the walls with the mid-height bond beam behaved separately from the lower half. The average ductility and energy dissipation of walls with joint reinforcement was greater than or approximately equal to those walls with deformed reinforcement. The energy dissipated in the peak loop of the wall with joint reinforcement exceeded the energy dissipated in the peak loop of the wall with deformed reinforcement.
